Manhole Inspection Summary

Manhole # S19I1_005MH

Insp Date: **4/18/08 1:05 PM**

Location Address: **2442 harriet av**

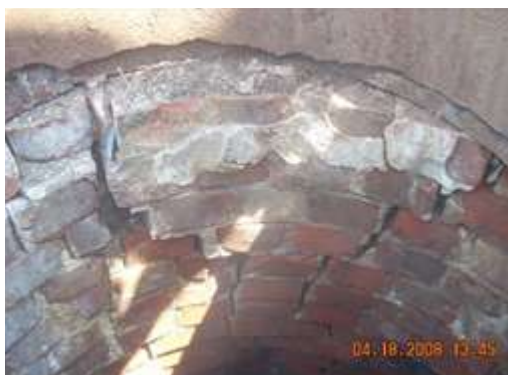
Misc. (Defect 5)

Comments **multiple open fractures of the corbel section compromising the structural integrity of the manhole**

additional view of cracked corbel wall

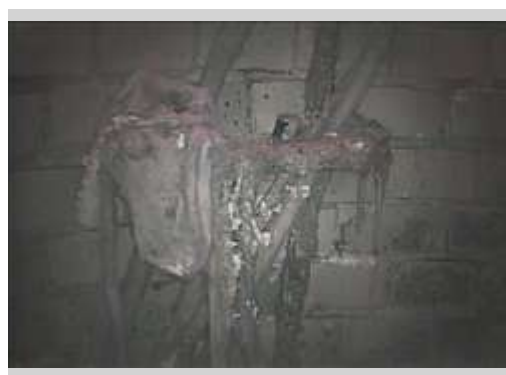
Defect 6

☒ **Evidence Of Surcharge** Depth: **5** (ft.) ☐ Active Surcharge Present

surcharge evidence

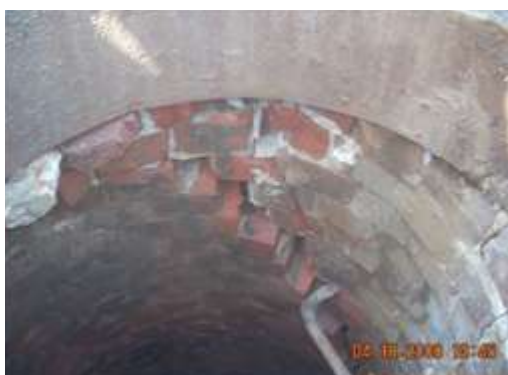
Defect 4

Condition: ☐ Sound ☒ **Cracked** ☐ Root Intrusion ☐ Loose Brick ☐ Deteriorated

cracked/fractured corbel wall

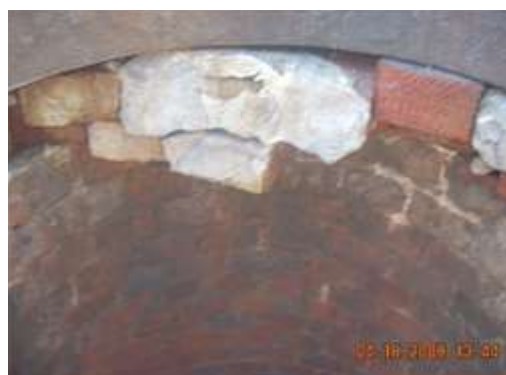
Defect 3

Condition: ☐ Sound ☐ Cracked ☐ Root Intrusion ☒ **Loose Brick** ☐ Deteriorated

loose chimney bricks

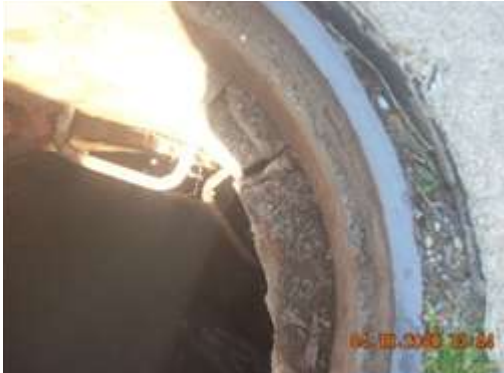
Defect 2

Offset: **2.5** (in.)

frame offset

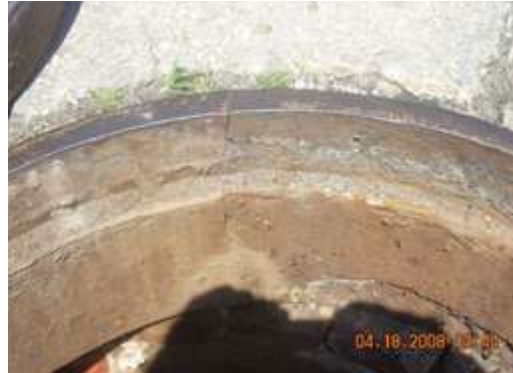
Defect 1

Condition: ☐ Sound ☒ **Cracked** ☐ Leaks

cracked frame
